Memorandum

Project #: 13539.00

Re: Center Trail Connection
 Phase 5 Feasibility Study
 Hopkinton, MA

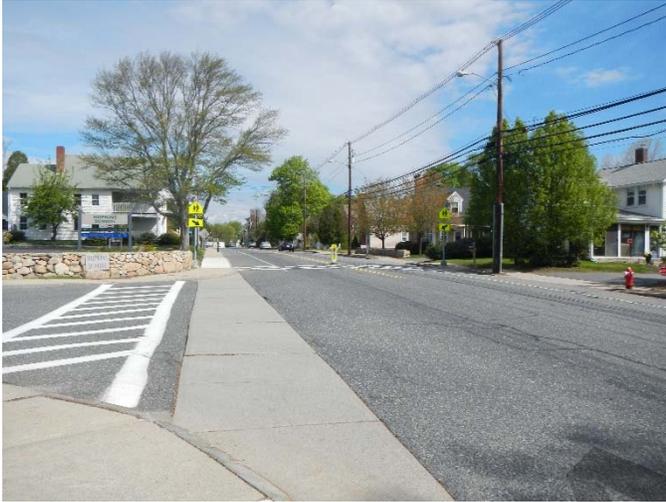
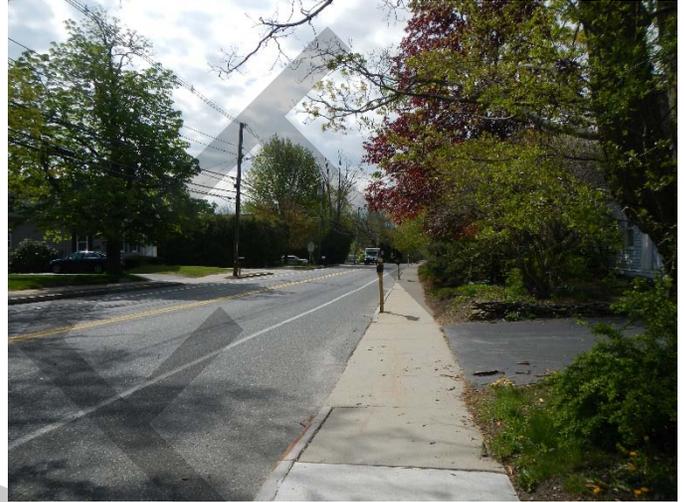
Figure 1 Loop Road – Sight Lines

Criteria	Threshold	Observed	Finding
<i>Sight Distance</i>	Meets AASHTO recommendations based on travel speeds and roadway grade	Clear sight lines in both directions, no obstructions noted.	No obstructions on existing sight lines.
<i>Vehicle Volume</i>	Average Daily Traffic does not exceed 15,000 vpd. If volumes exceed 15,000 vpd then operating speeds must be below 30 miles per hour	Ranges from approximately 11,000 to 15,000 vpd	ADT is approaching the threshold of 15,000 vehicles per day.
<i>Vehicle Speed</i>	Does not exceed 40 mph	20 mph posted speed limit 35 mph operating speed	Operating and Posted speeds do not exceed 40 mph. Operating speeds exceed the posted speed limit.
<i>Roadway Geometry</i>	Raised median recommended if daily vehicle volumes exceed 12,000 vpd	One travel lane in each direction, no raised median.	A raised median is recommended to reduce crossing distance, provide refuge, and facilitate ability for pedestrians to find gaps.

<i>Crosswalk Density</i>	Minimum distance to a marked crossing, 300 feet	Approximately 600 feet (uncontrolled crossing, EMC2 Park/McDermott Lane)	Exceeds 300 feet.
<i>Pedestrian Demand</i>	Minimum of 20 pedestrians during peak hour or 60 pedestrians over a peak four hour period	5-10 pedestrians per hour existing demand. Extension of the Upper Charles River Trail could generate needed demand.	Demand is feasible with trail extension.
<i>FHWA Recommendation</i>	Based on roadway geometry and traffic operating speed.	ADT volumes less than 15,000 vehicles per day at speeds of 40 mph	C – Site is a candidate for a marked crossing.
<i>Recommended Crosswalk Enhancements</i>	Crash history should be considered when evaluating any crosswalk to help further identify existing deficiencies. Existing crosswalk enhancements including pedestrian activated flashers, pedestrian warning signage, and in-street pedestrian signage are all desirable safety enhancements. Measures such as enforcement and traffic calming should be considered to address speeds exceeding the posted limit. Other potential crosswalk enhancements that could be considered at this location are continental style crosswalk striping, a raised median for refuge, and bump-outs to improve pedestrian visibility and sight lines.

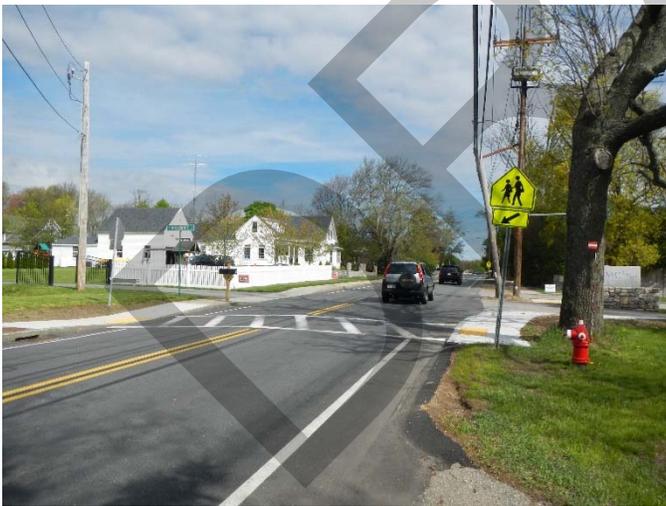
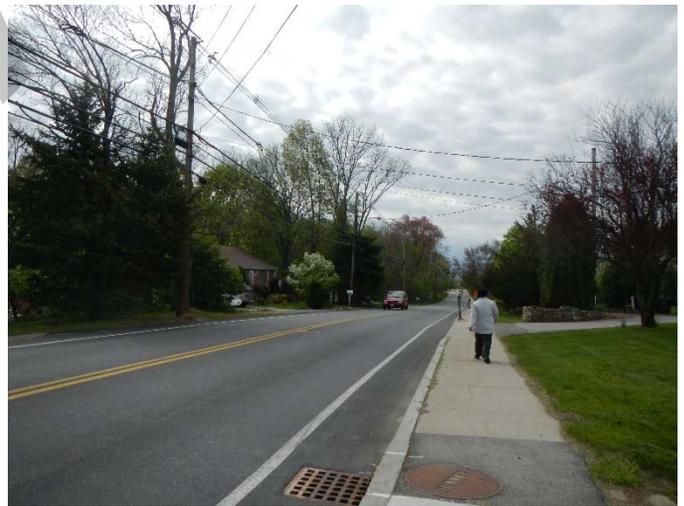
Figure 2 EMC2 Park/McDermott Lane – Sight Lines

Criteria	Threshold	Observed	Finding
<i>Sight Distance</i>	Meets AASHTO recommendations based on travel speeds and roadway grade	Clear sight lines in both directions, no obstructions noted.	No obstructions on existing sight lines.
<i>Vehicle Volume</i>	Average Daily Traffic does not exceed 15,000 vpd. If volumes exceed 15,000 vpd then operating speeds must be below 30 miles per hour	Ranges from approximately 11,000 to 15,000 vpd	ADT is approaching the threshold of 15,000 vehicles per day.
<i>Vehicle Speed</i>	Does not exceed 40 mph	40 mph posted speed limit 40 mph operating speed	Posted limit and operating speed approximately 40 mph.
<i>Roadway Geometry</i>	Raised median recommended if daily vehicle volumes exceed 12,000 vpd	One travel lane in each direction, no raised median.	A raised median is recommended to reduce crossing distance, provide refuge, and facilitate ability for pedestrians to find gaps.

<i>Crosswalk Density</i>	Minimum distance to a marked crossing, 300 feet	Approximately 600 feet (uncontrolled crossing, elementary school)	Exceeds 300 feet.
<i>Pedestrian Demand</i>	Minimum of 20 pedestrians during peak hour or 60 pedestrians over a peak four hour period	Less than 5 pedestrians per hour existing demand. Extension of the Upper Charles River Trail could generate needed demand.	Demand is feasible with trail extension.
<i>FHWA Recommendation</i>	Based on roadway geometry and traffic operating speed.	ADT volumes less than 15,000 vehicles per day at speeds of 40 mph	N – Marked crosswalk alone is not sufficient
<i>Recommended Crosswalk Enhancements</i>	Crash history should be considered when evaluating any crosswalk to help further identify existing deficiencies. Potential crosswalk enhancements to consider at this location include in-street pedestrian signage, continental style crosswalk pavement markings, a raised median for refuge, ADA compliant infrastructure for mobility, rectangular rapid flashing beacons, bump-outs to improve pedestrian visibility and sight lines. Given the proximity of the 20 mph travel zone and the entrance to EMC2 Park, feasibility of moving the beginning of the reduced speed zone should be investigated.

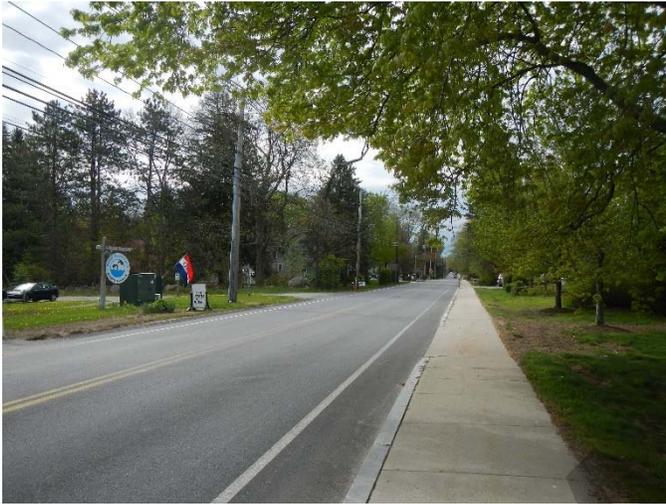
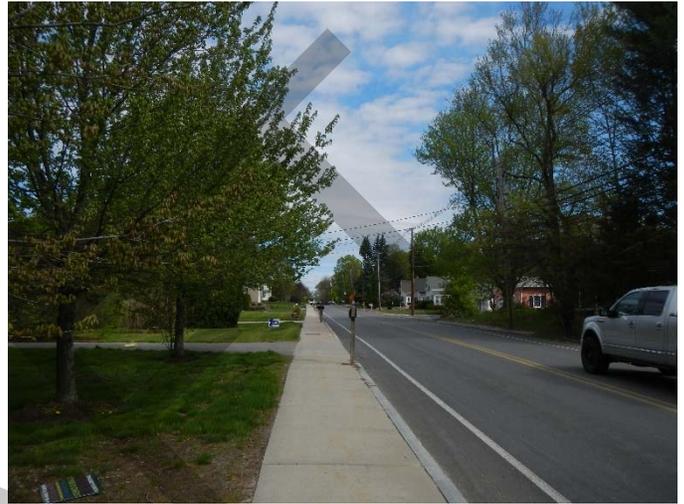
Figure 3 Water Fresh Farms – Sight Lines

Criteria	Threshold	Observed	Finding
<i>Sight Distance</i>	Meets AASHTO recommendations based on travel speeds and roadway grade	Clear sight lines in both directions, no obstructions noted.	Sufficient sight distance is likely achievable in the vicinity of Water Fresh Farm.
<i>Vehicle Volume</i>	Average Daily Traffic does not exceed 15,000 vpd. If volumes exceed 15,000 vpd then operating speeds must be below 30 miles per hour	Ranges from approximately 11,000 to 15,000 vpd	ADT is approaching the threshold of 15,000 vehicles per day.
<i>Vehicle Speed</i>	Does not exceed 40 mph	40 mph posted speed limit 40 mph operating speed	Posted limit and operating speed approximately 40 mph.
<i>Roadway Geometry</i>	Raised median recommended if daily vehicle volumes exceed 12,000 vpd	One travel lane in each direction, no raised median.	A raised median is recommended to reduce crossing distance, provide pedestrian refuge, and facilitate ability for pedestrians to find gaps.

<i>Crosswalk Density</i>	Minimum distance to a marked crossing, 300 feet	Approximately 700 feet (uncontrolled crossing, Chamberlain Street)	Exceeds 300 feet.
<i>Pedestrian Demand</i>	Minimum of 20 pedestrians during peak hour or 60 pedestrians over a peak four hour period	No existing demand. Extension of the Upper Charles River Trail could generate needed demand.	Demand is feasible with trail extension.
<i>FHWA Recommendation</i>	Based on roadway geometry and traffic operating speed.	ADT volumes less than 15,000 vehicles per day at speeds of 40 mph	N – Marked crosswalk alone is not sufficient
<i>Recommended Crosswalk Enhancements</i>	Crash history should be considered when evaluating any crosswalk to help further identify existing deficiencies. The 40 mph speed limit prohibits a marked crossing alone from being an appropriate implementation of a crosswalk Potential crosswalk enhancements to consider at this location include in-street pedestrian signage, continental style crosswalk pavement markings, a raised median for refuge, rectangular rapid flashing beacons, bump-outs to improve pedestrian visibility and sight lines.

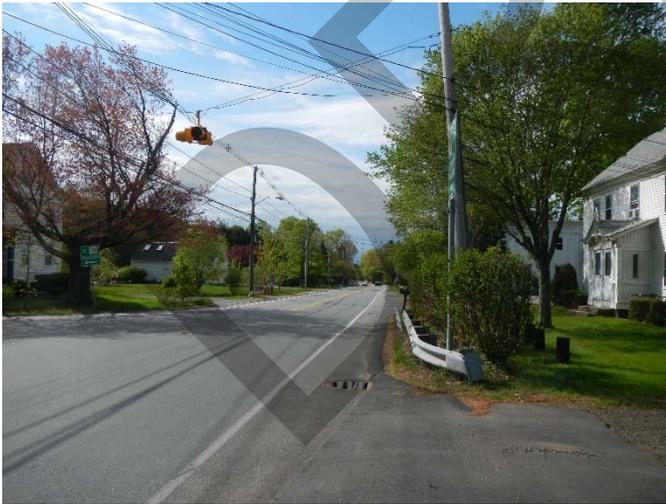
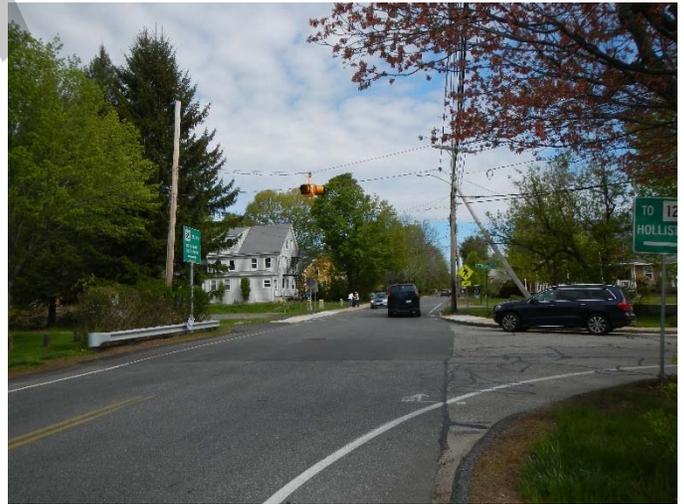
Figure 4 Chestnut Street – Sight Lines

Criteria	Threshold	Observed	Finding
<i>Sight Distance</i>	Meets AASHTO recommendations based on travel speeds and roadway grade	No observed sight distance impact at the existing crossing. Sight lines continue to remain clear moving north of the intersection. Moving south, horizontal curve begins to limit sight distance.	Sight lines at the intersection are clear and remain clear north of the intersection (easement 180/182 Hayden Rowe Street).
<i>Vehicle Volume</i>	Average Daily Traffic does not exceed 15,000 vpd. If volumes exceed 15,000 vpd then operating speeds must be below 30 miles per hour	Ranges from approximately 11,000 to 15,000 vpd	ADT is approaching the threshold of 15,000 vehicles per day.
<i>Vehicle Speed</i>	Does not exceed 40 mph	40 mph posted speed limit 43 mph operating speed	Posted limit and operating speed approximately 40 mph.
<i>Roadway Geometry</i>	Raised median recommended if daily vehicle volumes exceed 12,000 vpd	One travel lane in each direction, no raised median.	A raised median is recommended to reduce crossing distance, provide pedestrian refuge, and facilitate ability for pedestrians to find gaps.

<i>Crosswalk Density</i>	Minimum distance to a marked crossing, 300 feet	Approximately 400 feet (uncontrolled, Teresa Road)	Exceeds 300 feet.
<i>Pedestrian Demand</i>	Minimum of 20 pedestrians during peak hour or 60 pedestrians over a peak four hour period	Less than 5 pedestrians per hour existing demand. Extension of the Upper Charles River Trail could generate needed demand.	Demand is feasible with trail extension.
<i>FHWA Recommendation</i>	Based on roadway geometry and traffic operating speed.	ADT volumes less than 15,000 vehicles per day at speeds of 43 mph	N – Marked crosswalk alone is not sufficient
<i>Recommended Crosswalk Enhancements</i>	Crash history should be considered when evaluating any crosswalk to help further identify existing deficiencies. The 40 mph speed limit prohibits a marked crossing alone from being an appropriate implementation of a crosswalk Potential crosswalk enhancements to consider at this location include in-street pedestrian signage, continental style crosswalk pavement markings, a raised median for refuge, rectangular rapid flashing beacons, bump-outs to improve pedestrian visibility and sight lines. Should a traffic signal be warranted, signalization would be an appropriate enhancement as well.

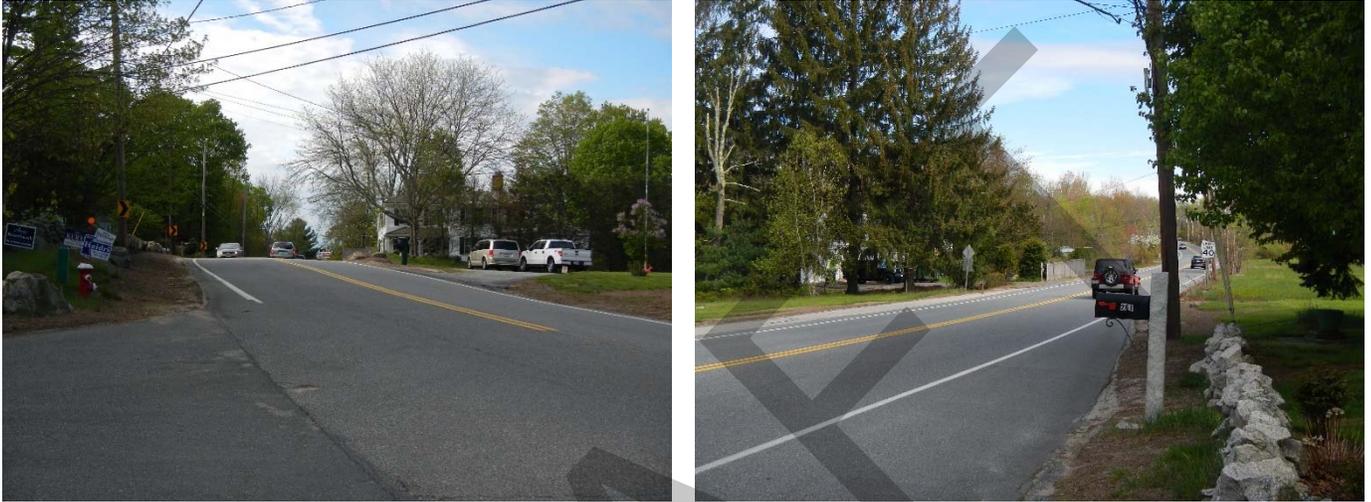
Figure 5 College Street – Sight Lines

Criteria	Threshold	Observed	Finding
<i>Sight Distance</i>	Meets AASHTO recommendations based on travel speeds and roadway grade	Vertical curve limits sight lines, sufficient sight distance cannot be achieved traveling NB or looking left.	Sufficient sight distance cannot be achieved at this location.
<i>Vehicle Volume</i>	Average Daily Traffic does not exceed 15,000 vpd. If volumes exceed 15,000 vehicles per day then operating speeds must be below 30 miles per hour	Ranges from approximately 11,000 to 15,000 vpd	ADT is approaching the threshold of 15,000 vehicles per day.
<i>Vehicle Speed</i>	Does not exceed 40 mph	30 mph posted speed limit 43-46 mph operating speed	Posted limit does not exceed 40 mph, however, operating speed does exceed 40 mph.
<i>Roadway Geometry</i>	Raised median recommended if daily vehicle volumes exceed 12,000 vpd	One travel lane in each direction, no raised median.	A raised median is recommended to reduce crossing distance, provide pedestrian refuge, and facilitate ability for pedestrians to find gaps.

<i>Crosswalk Density</i>	Minimum distance to a marked crossing, 300 feet	Approximately 4,000 feet (uncontrolled crossing, Chestnut Street)	Exceeds 300 feet
<i>Pedestrian Demand</i>	Minimum of 20 pedestrians during peak hour or 60 pedestrians over a peak four hour period	No existing demand. Extension of the Upper Charles River Trail could generate needed demand.	Demand is feasible with trail extension.
<i>FHWA Recommendation</i>	Based on roadway geometry and traffic operating speed.	ADT volumes less than 15,000 vehicles per day at speeds of 43-46 mph	N – Marked crosswalk alone is not sufficient
<i>Recommended Crosswalk Enhancements</i>	Due to the limited sight distance caused by the horizontal and vertical curves in the roadway alignment this location is not a desirable location for an uncontrolled crossing. A signalized crossing such as a hybrid pedestrian beacon (often referred to as a HAWK) would be an appropriate signalized crossing if warranted.

- Generally speaking, appropriate sight lines can be achieved for potential crossing locations north of College Street. Locations south of College Street (including the intersection with College Street) have significant sight distance constraints due to horizontal and vertical curve limitations in the roadway alignment.
